Digital Visual Inspection of Coils

Visual inspection systems have been widely used throughout the steel industry for detecting defects in coils. A digital visual inspection system was developed and implemented at the Finishing Division Mittal Steel USA-Cleveland. This system is low cost, low maintenance and has been successful in operation as an inspection tool for the last 4 years. This has allowed disposition of coils without incurring additional line inspection and has provided a means to review coils involved in customer claims. It has also been a valuable tool in monitoring mill operations. This paper describes the system, its uses and some of the practical applications.

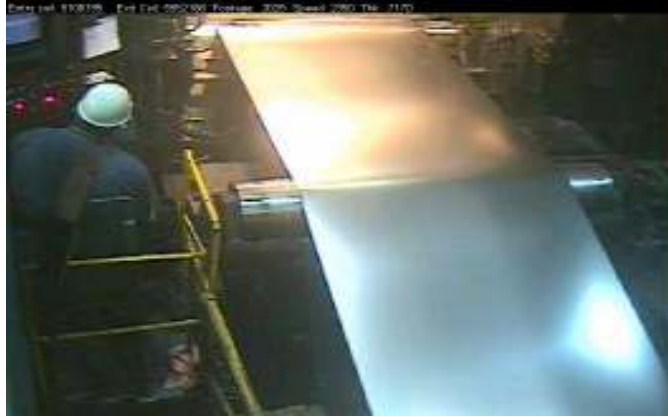
Figure 2 shows what anyone with network access can see during coil production. Quality engineers frequently review these images to make coil dispositions and investigate customer claims.

Figure 2 - Online/offline production images include parameters like coil number, gauge, speed, footage, etc., making the disposition of the coil much quicker

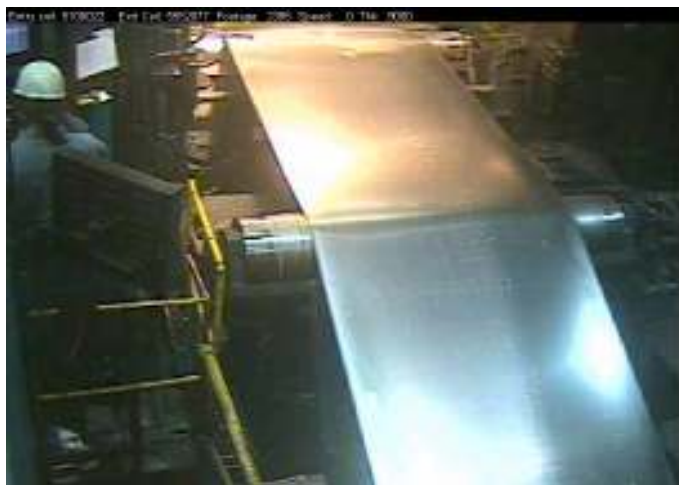
Figure 3 - Roller failed to detect the defect, but upon reviewing, the coil image quality inspector identified it

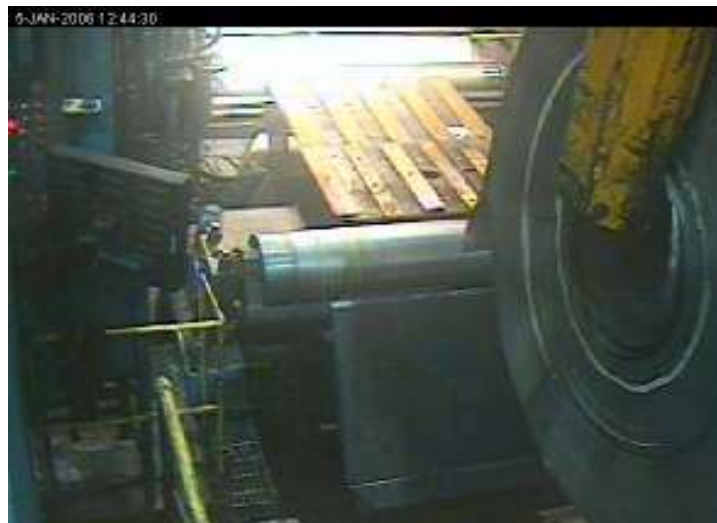
The following two figures exemplify a Temper Mill wreck caused by poor incoming winding. Figure 4 shows the coil being loaded with damaged a sidewall. Figure 5 shows the mill wreck with the coil running at high speed instead of being processed at a lower speed. The coil would have been acceptable if processed at a lower speed.

Figure 4 – Coil is chalk-marked with winding problem as it is loaded

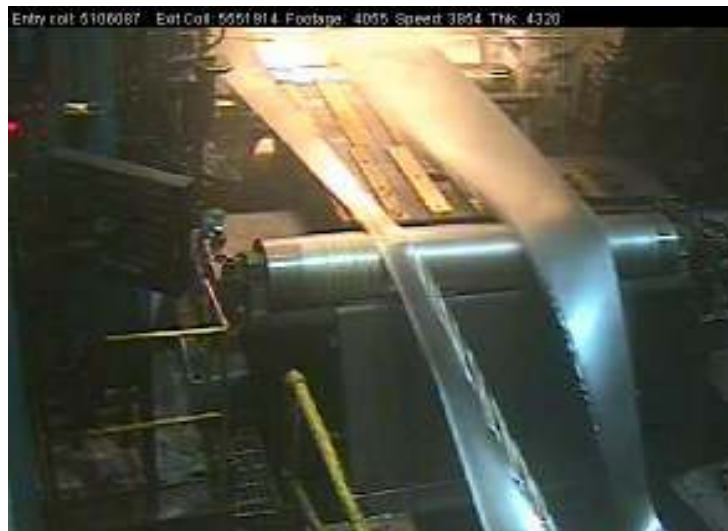
Figure 5 – Coil breaks entering the mill

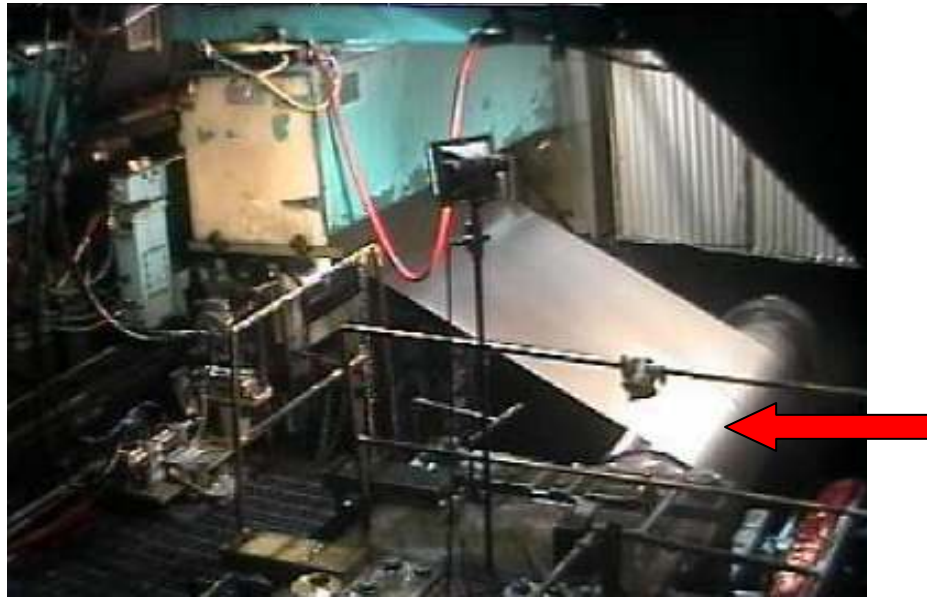
Figure 6 shows a crease that carried through the entire coil. Review of the video images showed that shortly after the coil entered the belt wrapper, the mill was reversed. This caused the defect to occur throughout the coil.

Figure 6 – Mill backed up after belt wrapper came in causing crease that carried through entire coil

- Friction digs that were the result of improper arbor insertion
- Edge breaks damage that was not repaired prior to temper rolling
- Torn edges and stickers from poor incoming winding
- Mill wrecks resulting from people not reacting correctly to incoming conditions
- Oiler not in position for product (dry up/oiled down)
- Exit saddle left in the up position (responsible for many wrecks)
- Exit table failed to lower (resulting in mill wrecks)
- Creases on the exit reel due to bad start (see figure 6)
- Belt wrapper problems (broken or binding belt)

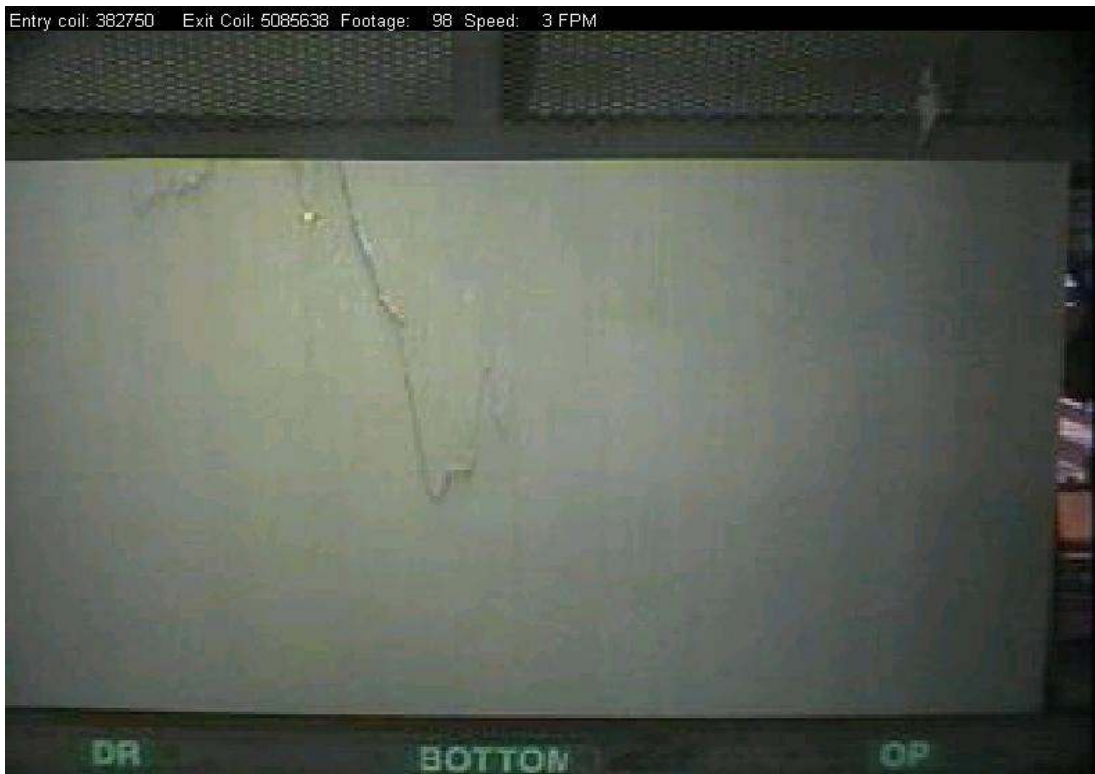
After reviewing the inspectors comments, the video image confirms the severity of the defect, but shows the defect actually occurred at 98 feet.

Figure 9 - The image of the suspected coil was reviewed and the exact location of the defect was found

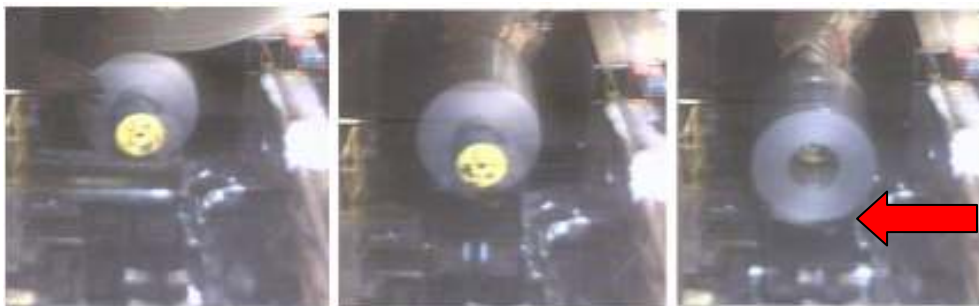
A coil falling into the pit raised safety concerns regarding proper functionality of the equipment. The coil was being moved from the tension reel to the exit conveyor. No one saw what happened, so the cause was not known. Figure 13 shows the coil movement, tailing out, mandrel collapsing and coil being removed from the tension reel with a loose flap.

Figure 13 – Normal removal of coil.

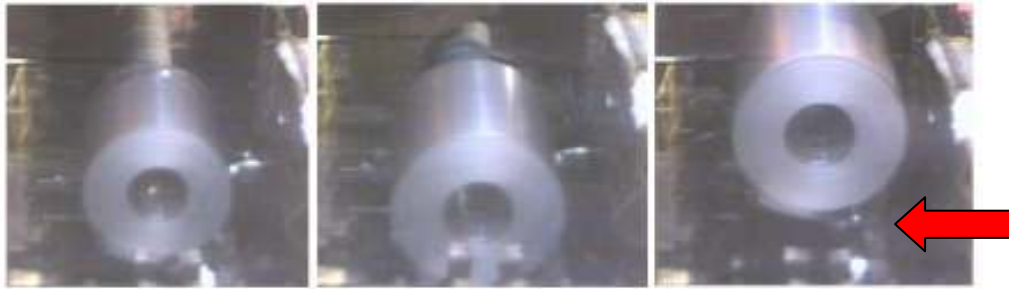
Figure 14 has three pictures, the first two showing normal movement. The third picture shows the buckle catching on the conveyor pad.

Figure 14 – Buckle hitting the conveyor pad

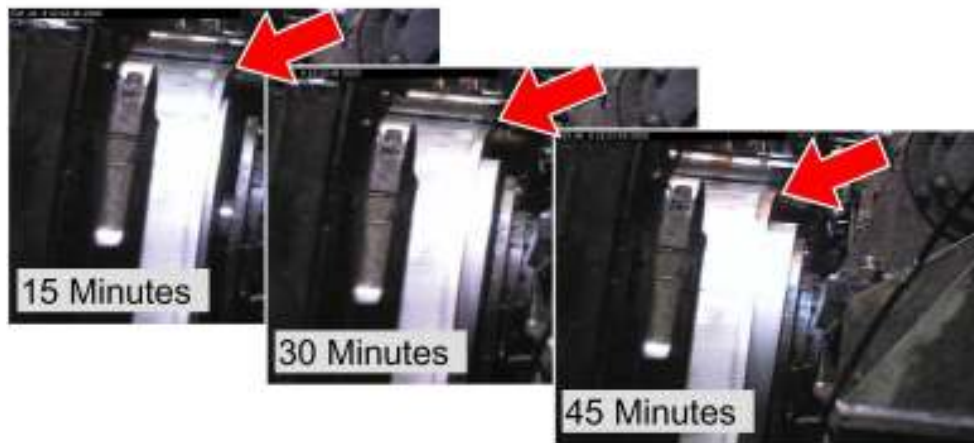
Figure 17 – Uncoiler drifts forward causing coil to loosen and telescope.

Another example involved unexplainable stand #1 wrecks that were occurring two to three times per month. Review of the VCS video after one such wreck showed that during mill delays, the uncoiler would slowly rotate forward, loosening the laps and causing the coils to telescope due to loose tension.

When the mill would re-start, the arbor centering system was unable to compensate for the severe telescope resulting in the strip going over the sideguides and causing a wreck. Maintenance personnel reviewed the video and traced the cause to out-of-adjustment brakes on the uncoiler motors. The brakes were repaired and the stand #1 mill wrecks were virtually eliminated.
